OOAMA AIRMUNITIONS TEST REPORT

DISPOSAL TESTS

AIR-2A "GENIE" ROCKET MOTORS

SERVICE ENGINEERING DIVISION

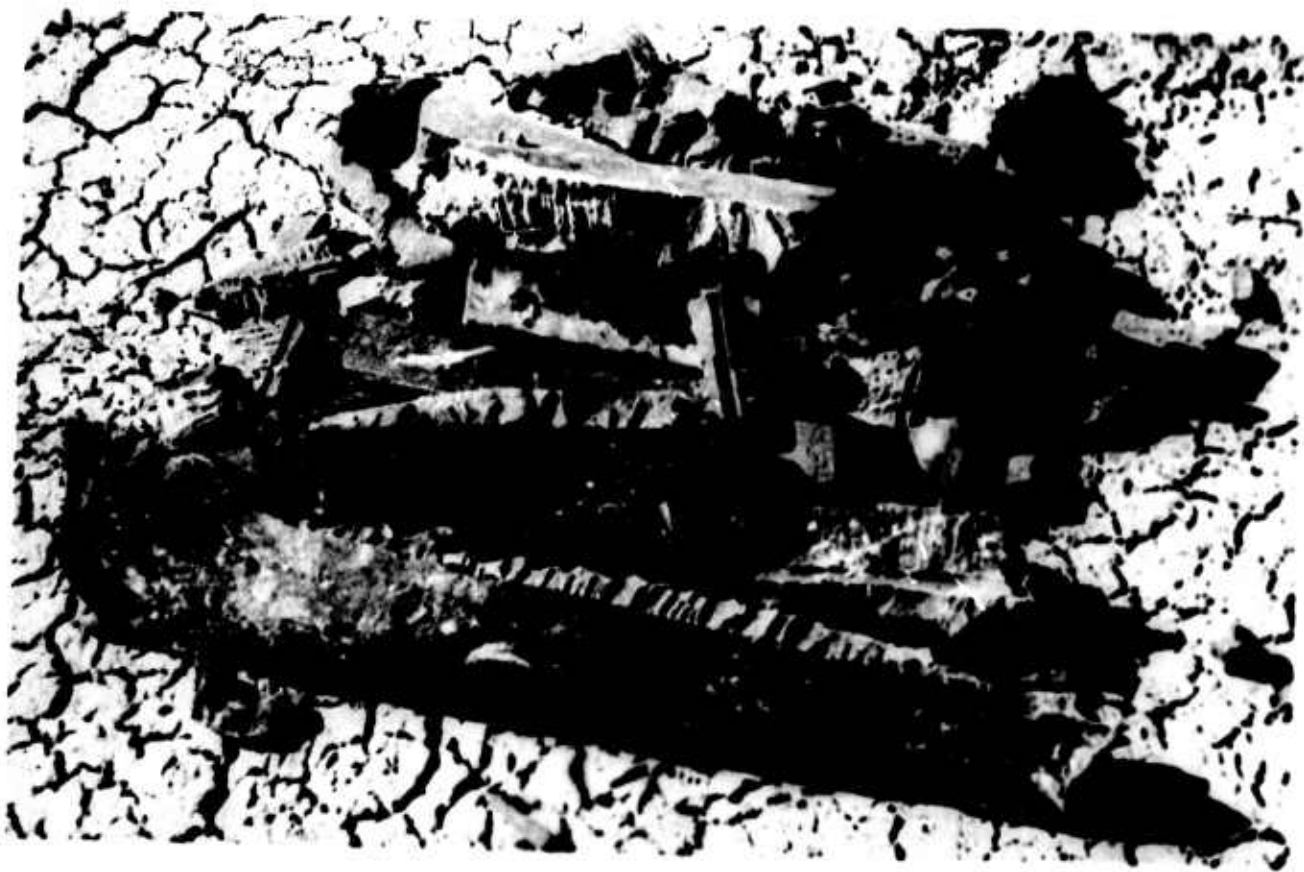
FIGURE 12: A PHOTOGRAPH OF THE UNBURNED PROPELLANT EJECTED DURING TEST 2.

The detonating cord assembly detonated with such force that approximately one-third of the rocket motor propellant grain was vertically ejected to a height of 40-90 feet. The propellant did not ignite and was scattered within 100 feet of the test area. There was no evidence of burning propellant being ejected from the hole in which the motor was placed. A post test examination of the rocket motor showed that the detonating cord assembly severed the motor longitudinally, at the forward dome and at the aft end. The remaining two-thirds of the propellant that was not ejected was ignited by the detonating cord assembly and burned at the test site. (See Figures 12 through 14)

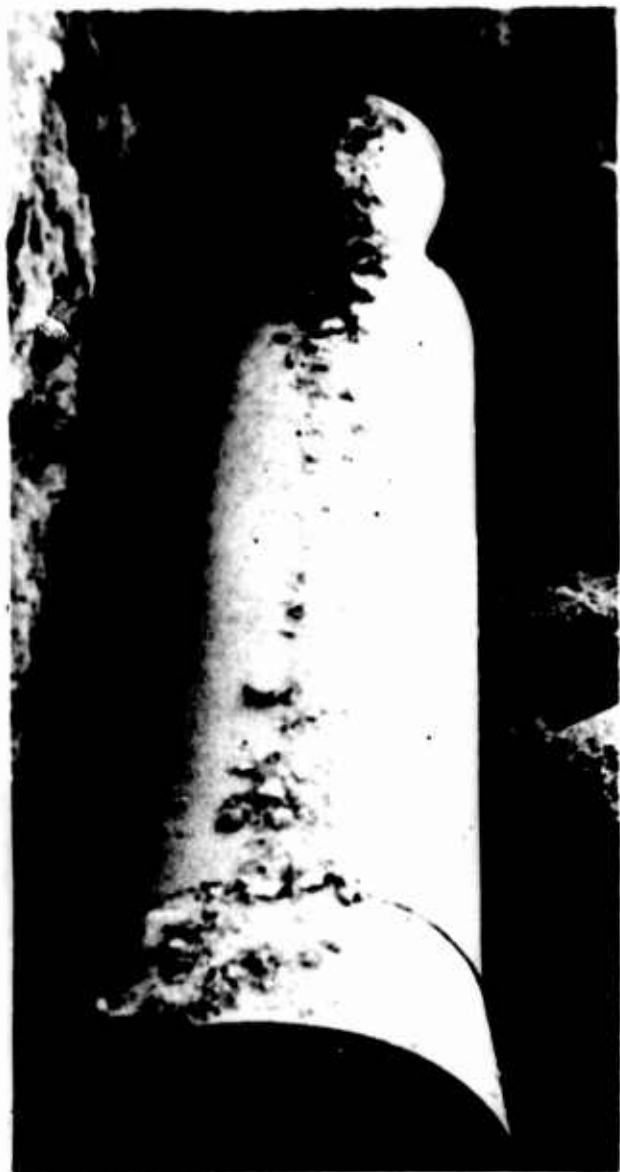
FIGURE 18: THE REMAINS OF THE ROCKET MOTOR
AFTER INITIATION OF THE DETONATING
CORD. (TEST 4)
